International Atomic Energy Agency

***Radiological Report on an  
Inter-Agency mission to the  
Shinkolobwe mine site***

Democratic Republic of Congo

24 October to 4 November 2004

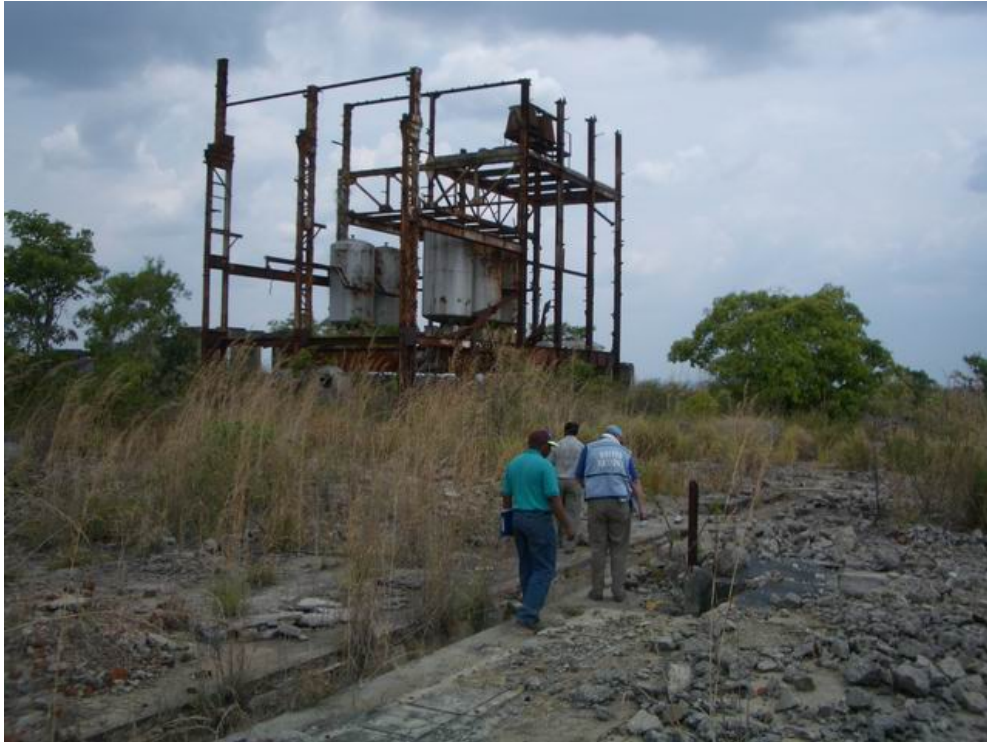
Figure 1: Remnant infrastructure at the former mill area  
(photo: Rene Nijenhuis, Joint UNEP/OCHA Environment Unit)

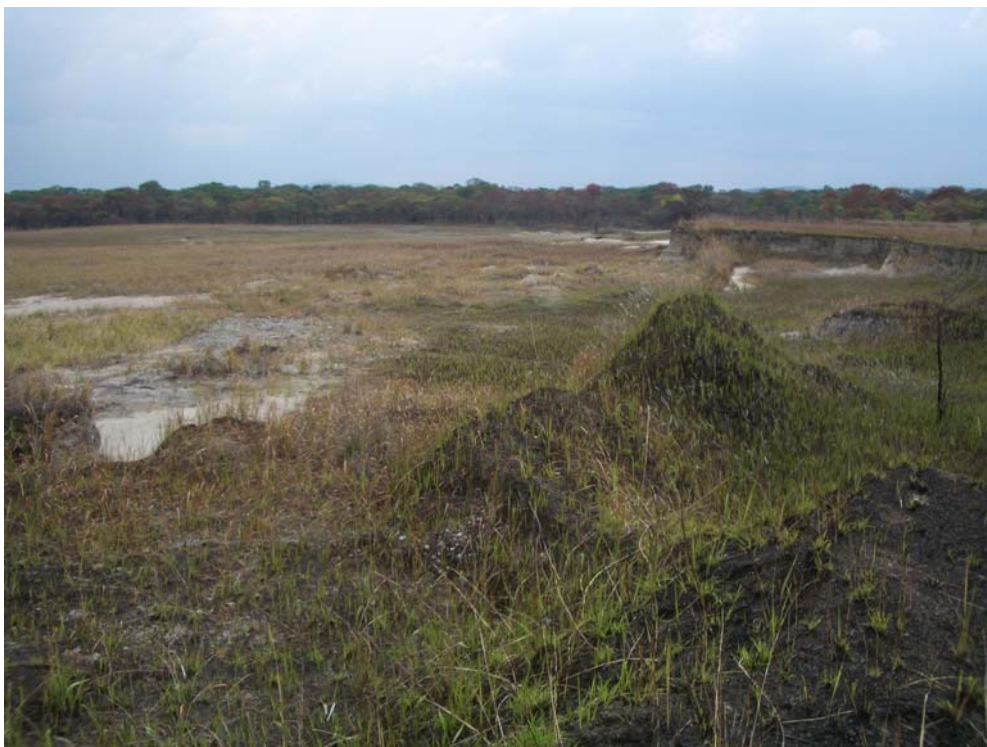
Tailings from the former formal uranium mining operations are exposed and have been “mined” in a few locations (Figure 2); also waste rocks with varying degrees of uranium mineralization may be found all over the site and could represent a radiological safety hazard.

Figure 2: View southwards across western tailings area  
(photo: Rene Nijenhuis, Joint UNEP/OCHA Environment Unit)

relocation of tailings and mineralised waste rocks to the former mine pit and the collapsed workings to the greatest extent possible, and

containment of all remaining contaminated residues in accordance with current best practice principles of waste safety and waste management.
